Battleship TEXAS Project Update

Report Number: 001
Report Period: February 1, 2013 through July 31, 2013
Purpose: Per the Programmatic Agreement (PA) among the Department of the Navy (Navy), the Texas Historical Commission (THC), Texas Parks and Wildlife Department (TPWD) and the Advisory Council on Historic Preservation (ACHP) concerning the Battleship Texas, TPWD is required every six months to submit a summary report detailing the work done on the ship pursuant to the terms of the PA. This document is intended to meet that requirement for the period indicated above.

Structural Repair of Battleship Texas

Photos and Exhibits Report 001

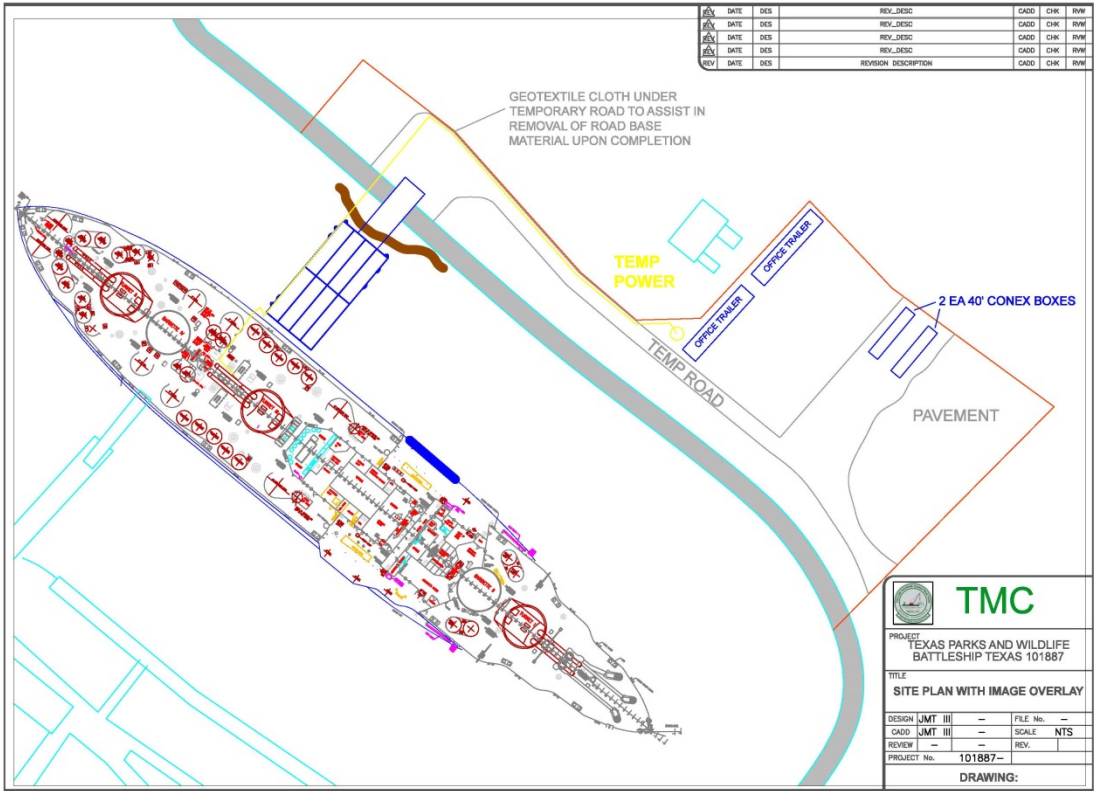
March 2013

Layout of approved construction Staging Area.

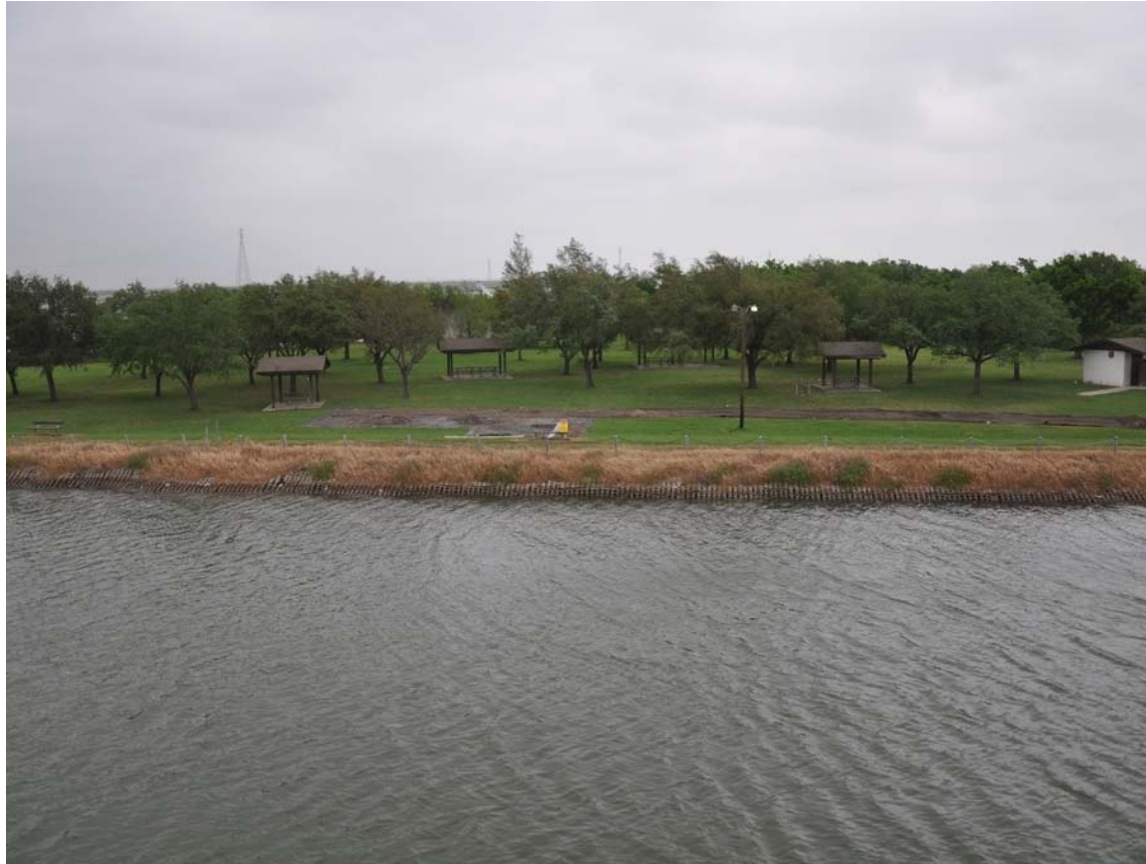
April 2013

East end of Staging Area on north side of ship slip at beginning of construction.

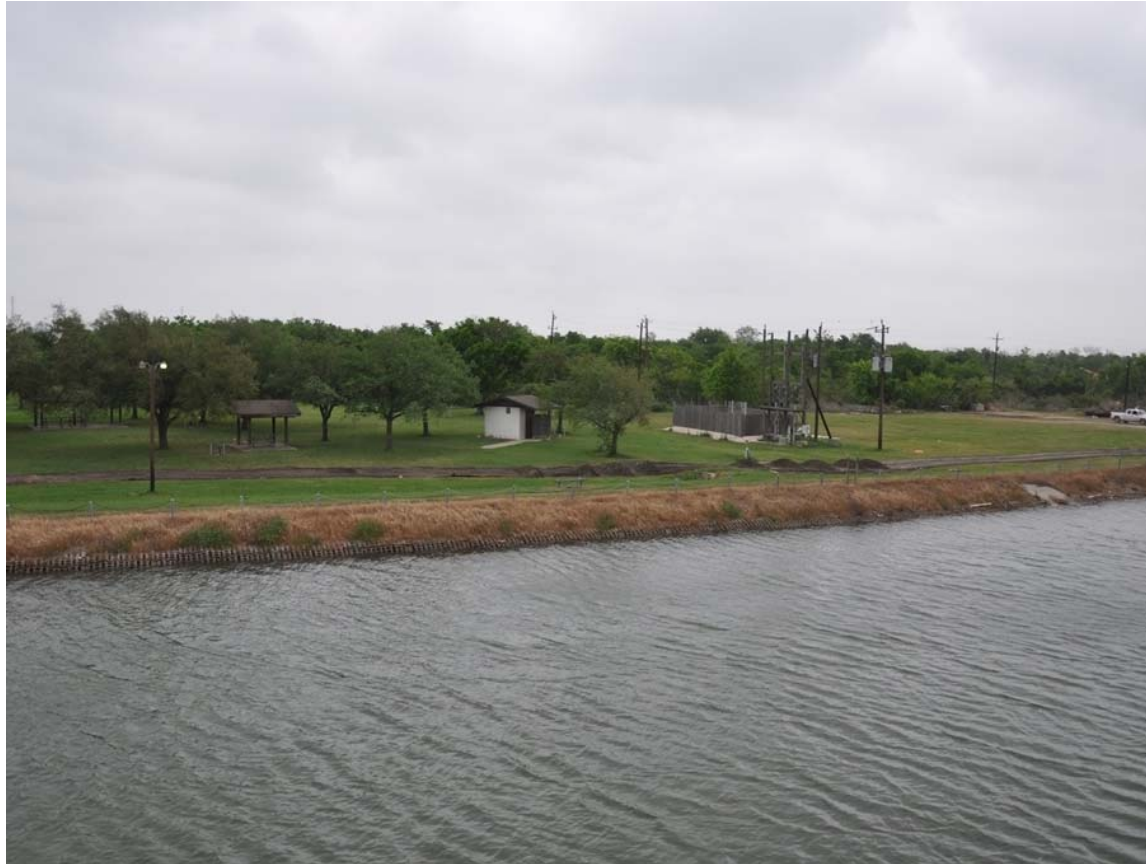
April 2013

West end of Staging Area on north side of ship slip at beginning of construction.

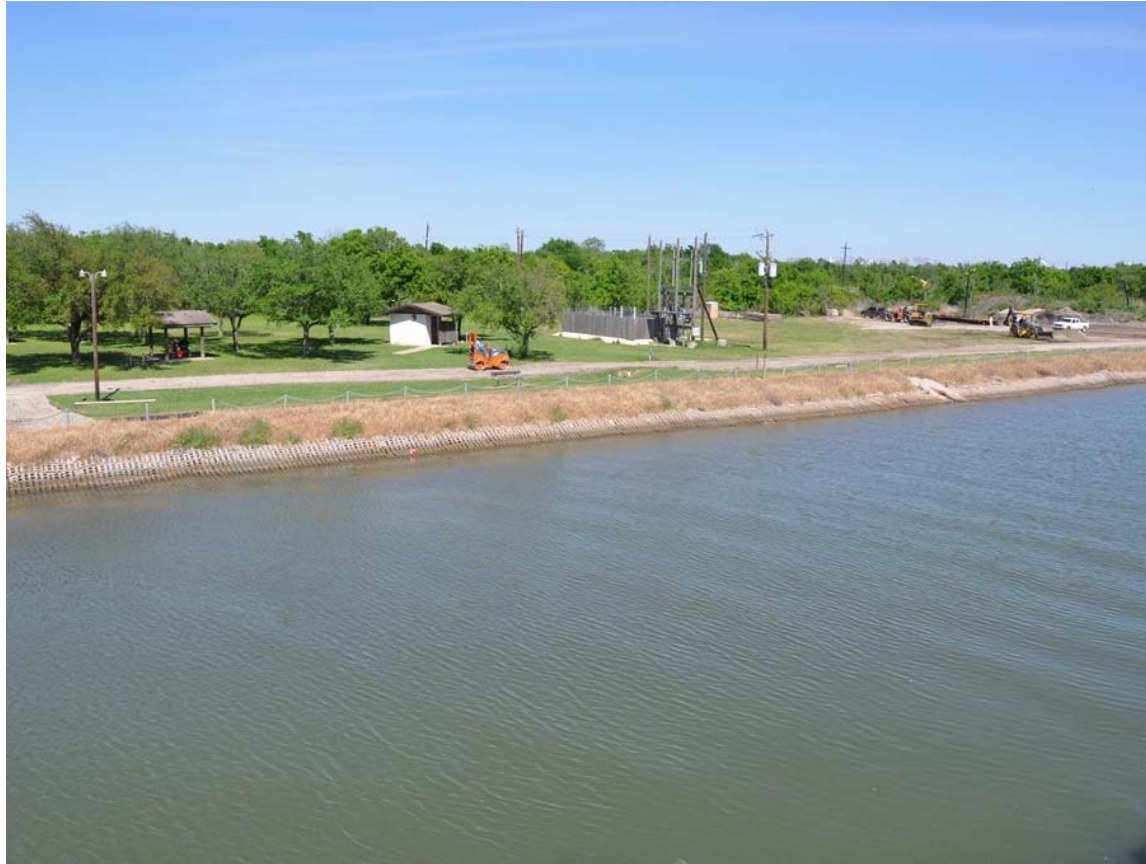
April 2013

Staging Area on north side of ship slip at beginning of construction.

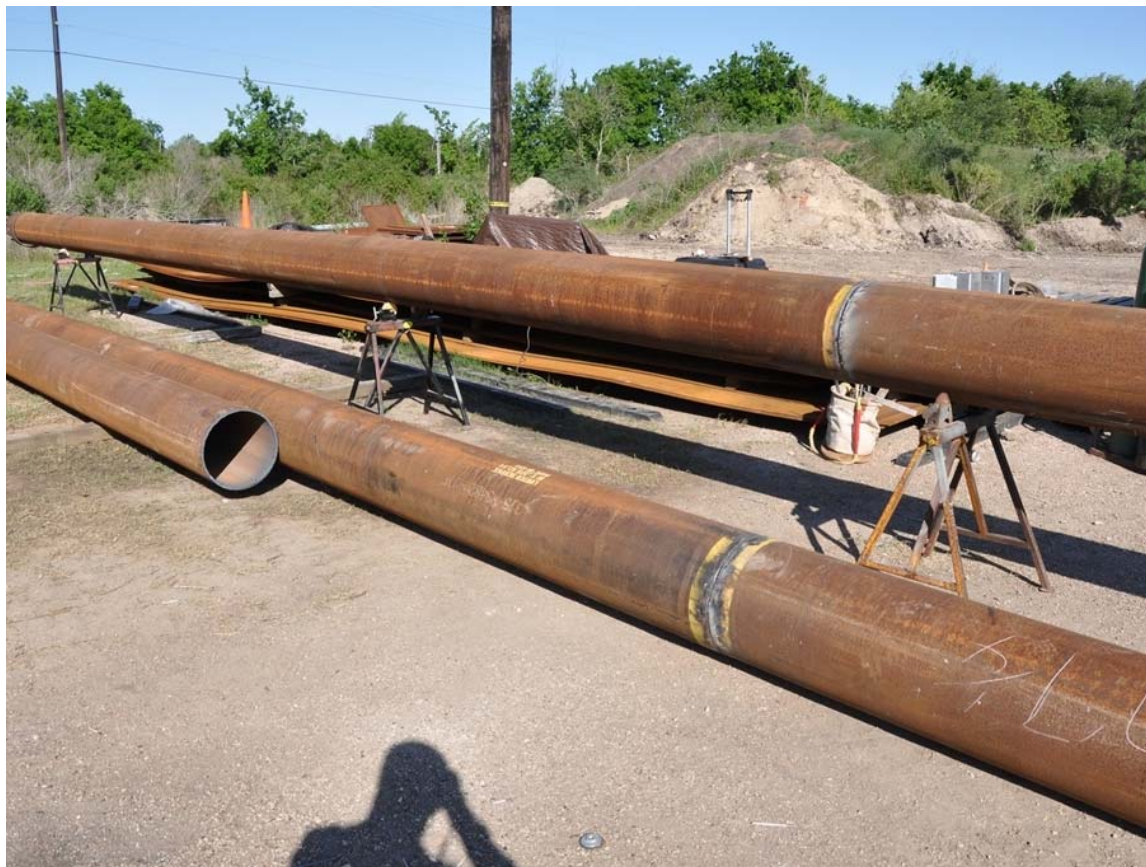
April 2013

Construction of spuds to secure spud barges.

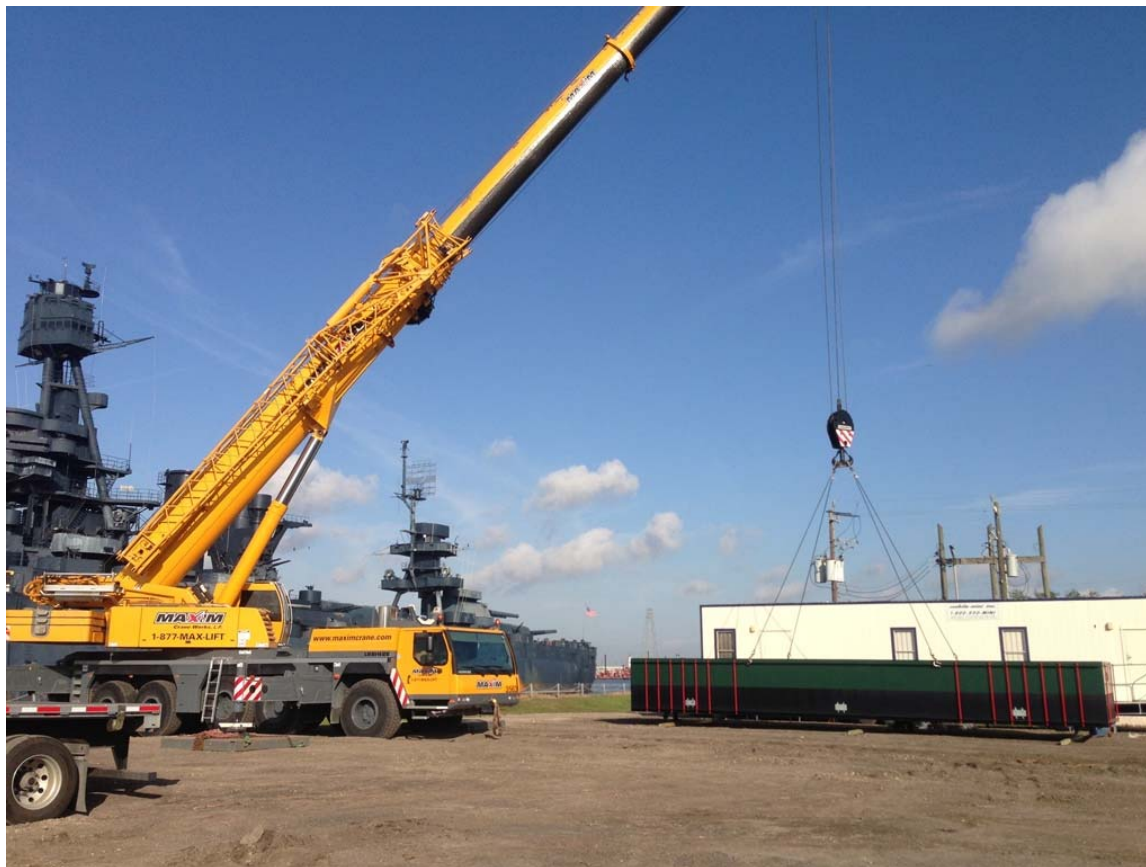
April 2013

Delivery and unloading of spud barge sections.

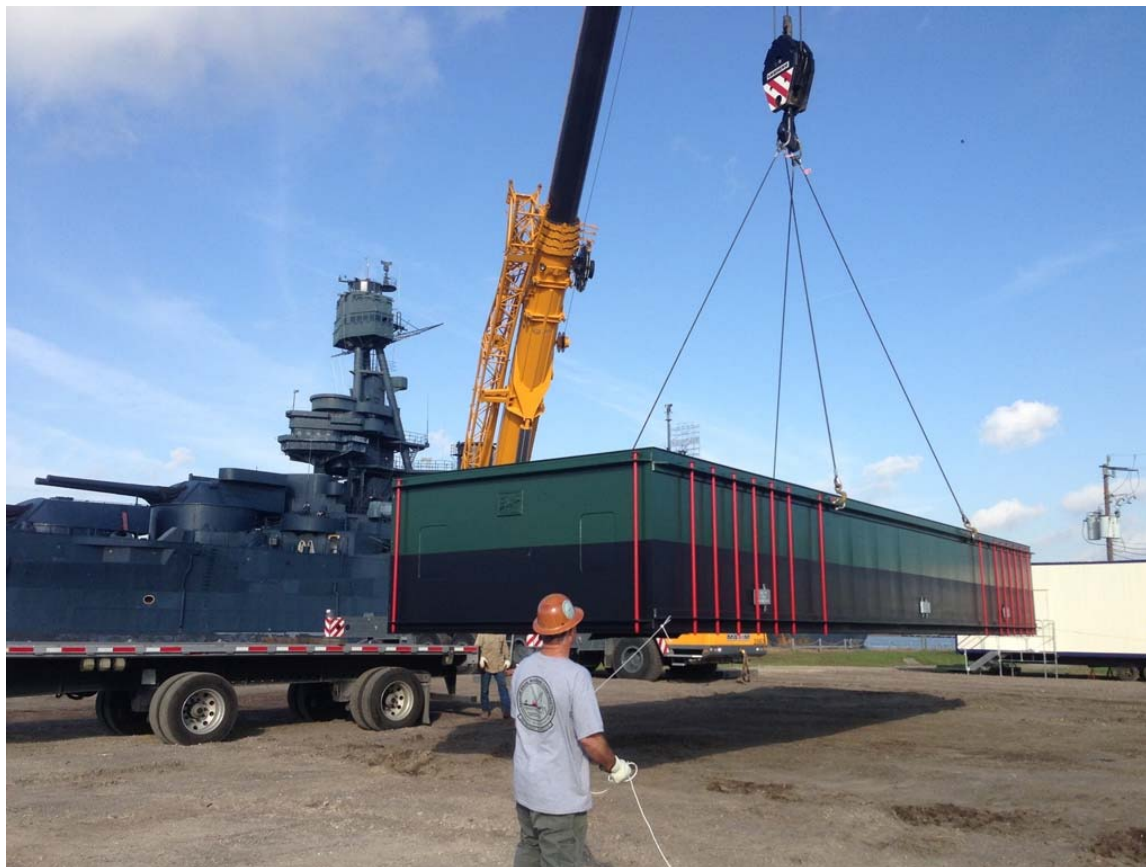
April 2013

Delivery and unloading of spud barge sections.

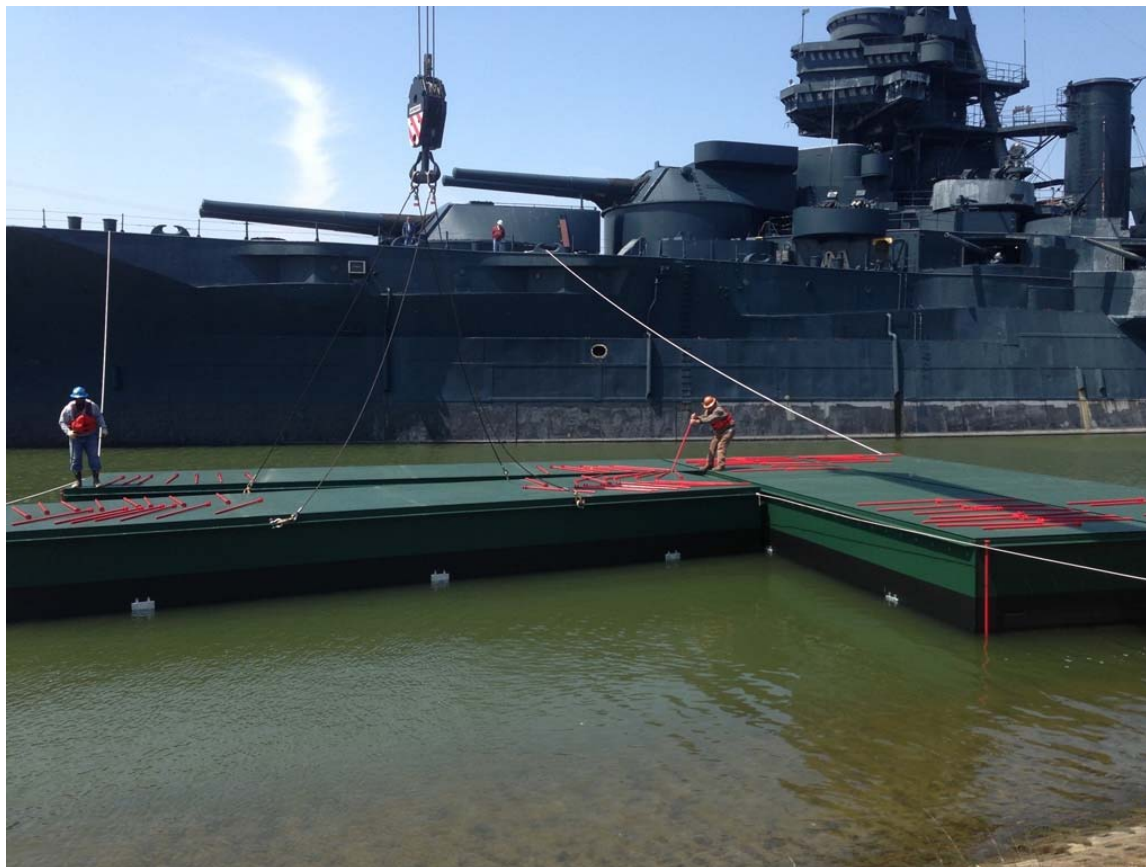
April 2013

Assembly of floating spud barge sections (8 total sections).

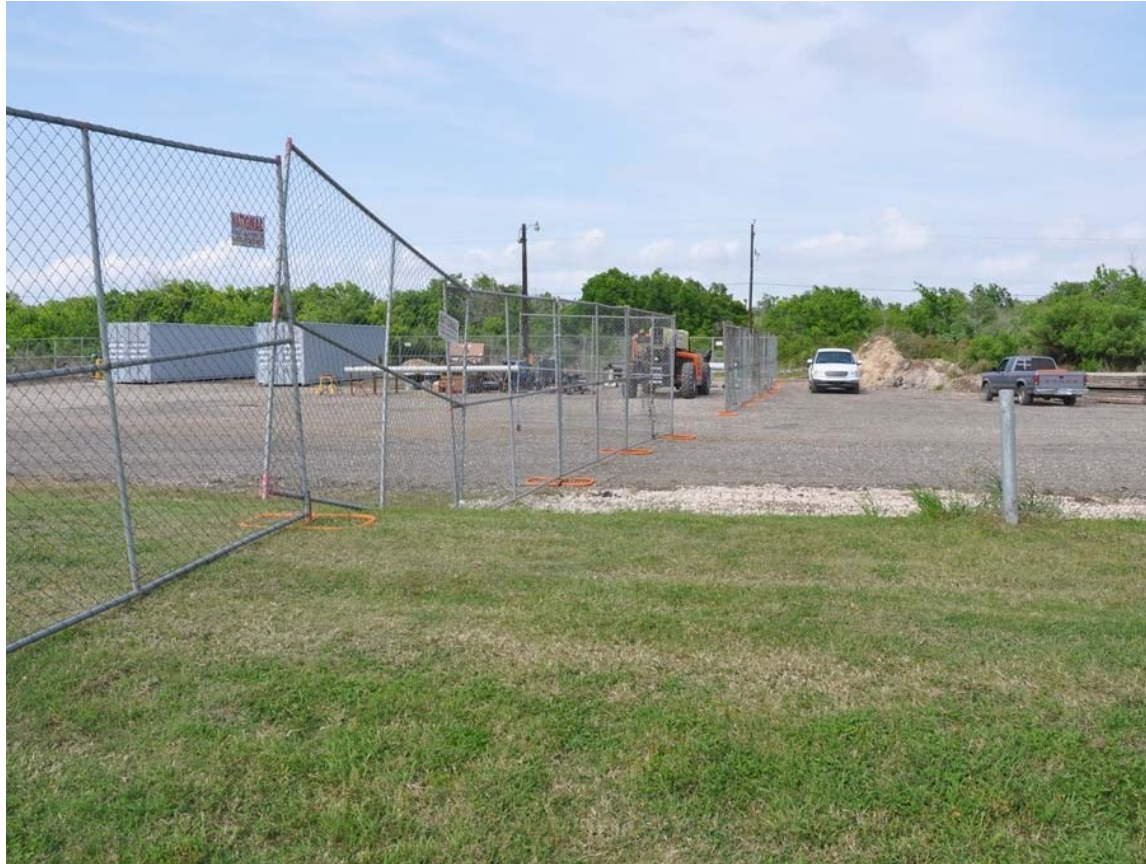
April 2013

Temporary construction fencing bounding construction Staging Area.

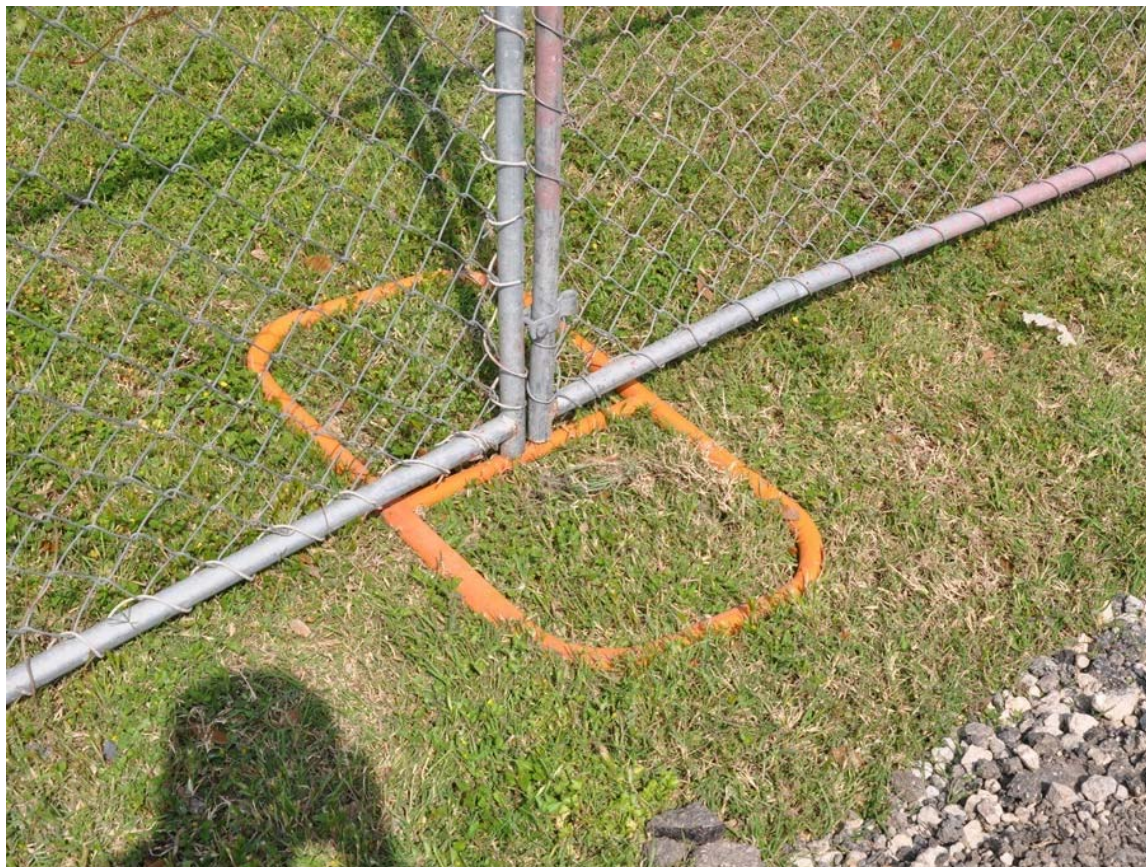
April 2013

Close-up of temporary construction fencing bounding construction Staging Area.

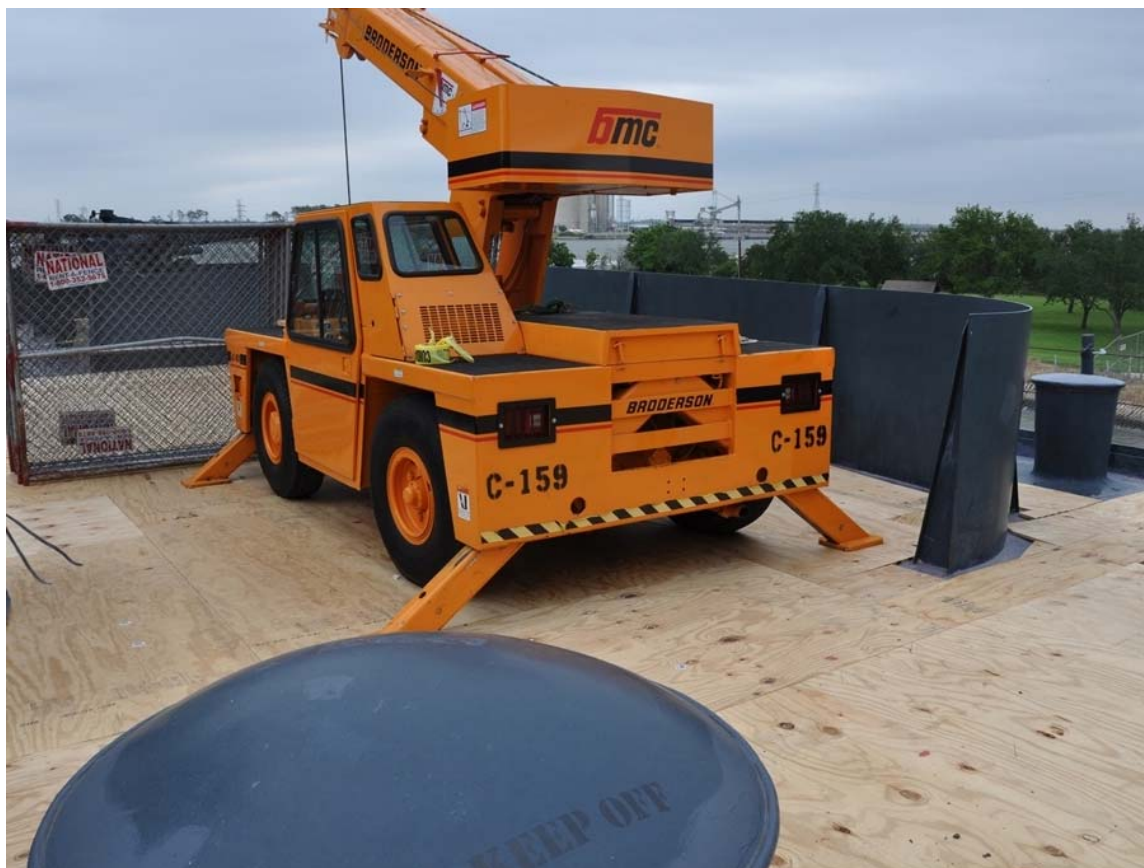
May 2013

"Carry Deck" equipment installed on deck of ship. Note plywood deck protection.

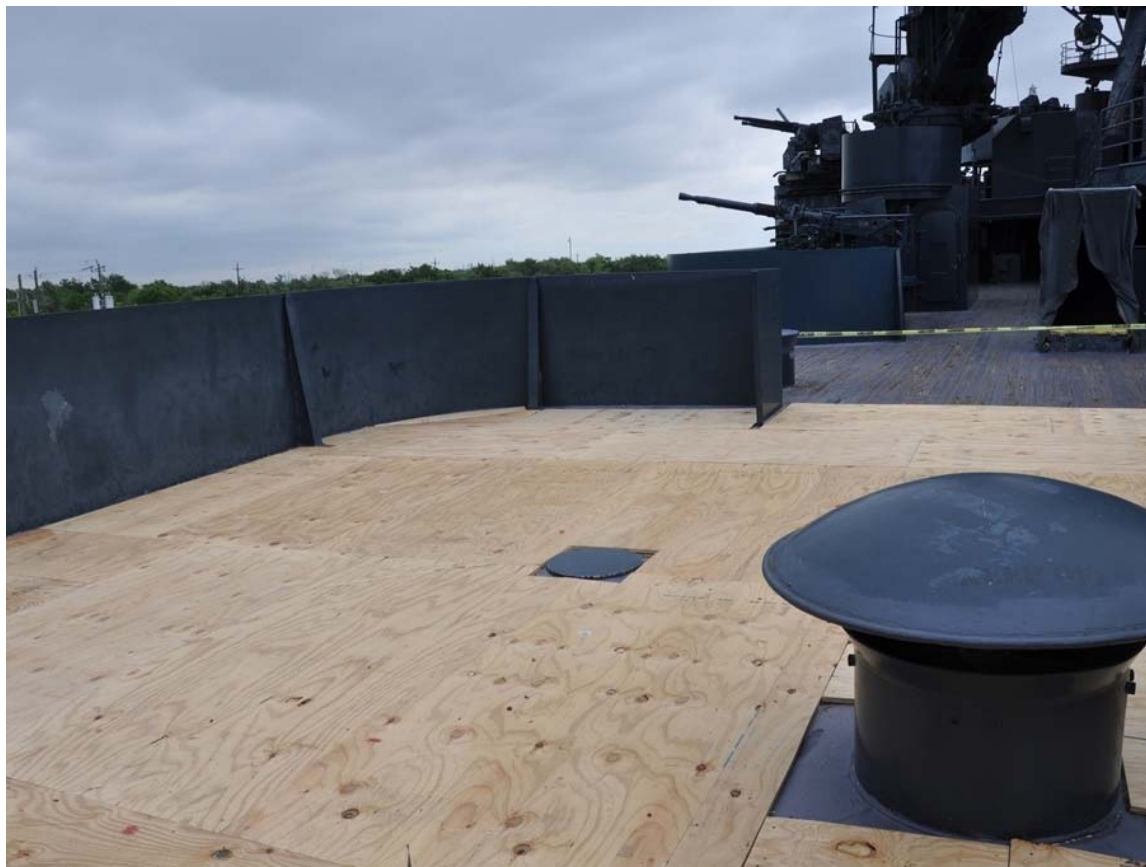
May 2013

Plywood ship deck protection.

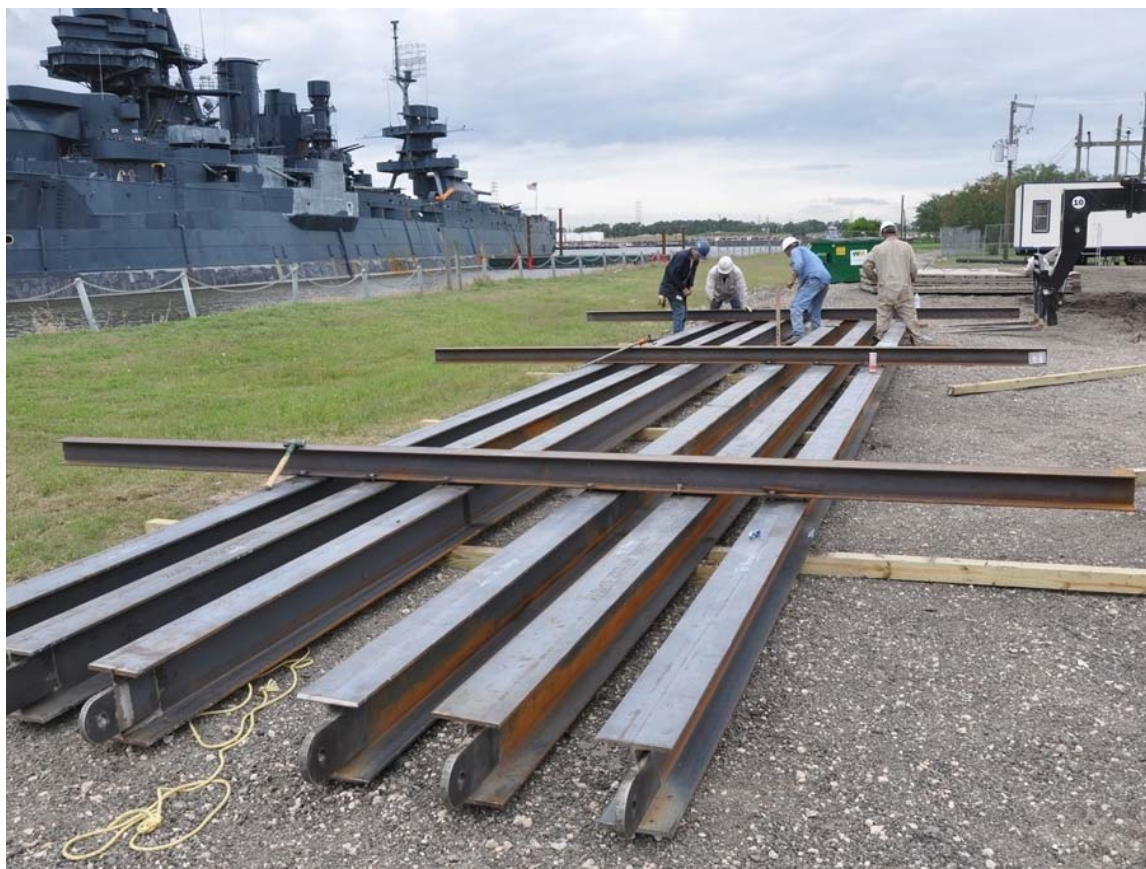
May 2013

Fabrication of equipment access ramp (to be installed from shore to spud barge assembly).

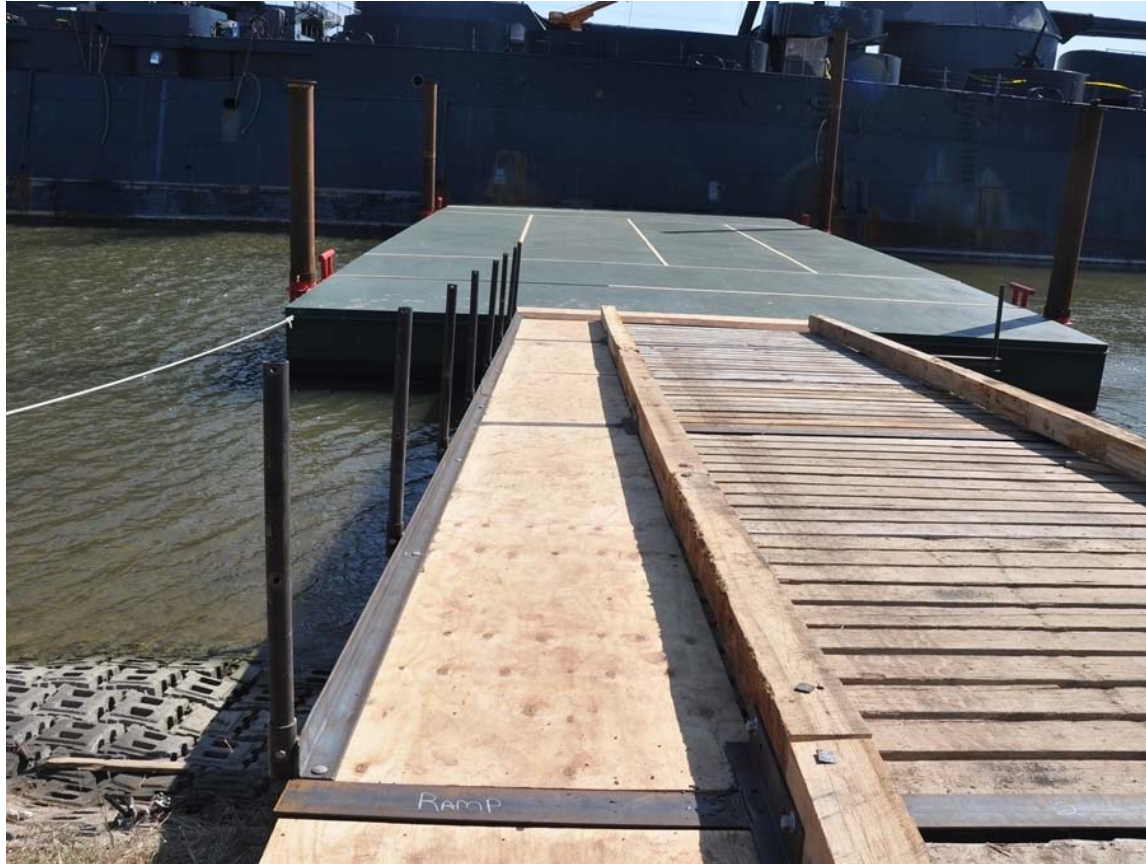
May 2013

Installed equipment access ramp.

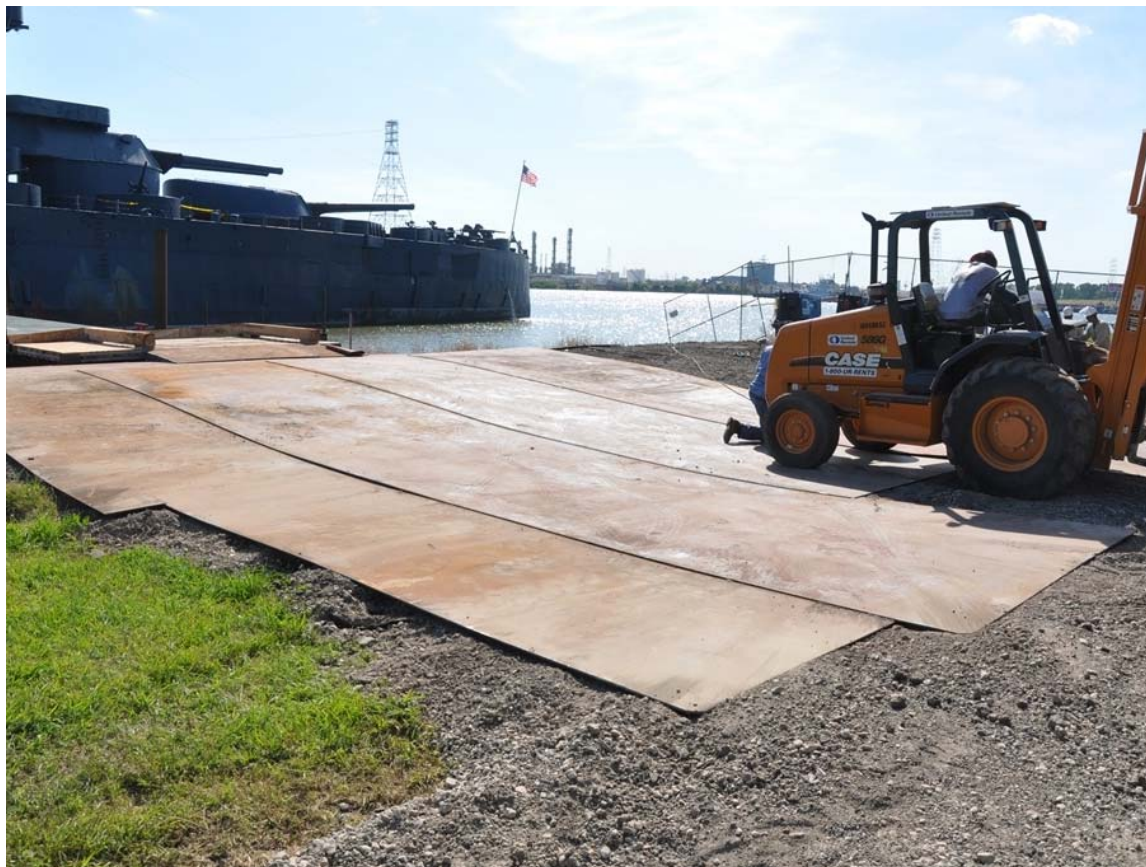
May 2013

Steel plate approach to equipment access ramp. Donated plate used for approach.

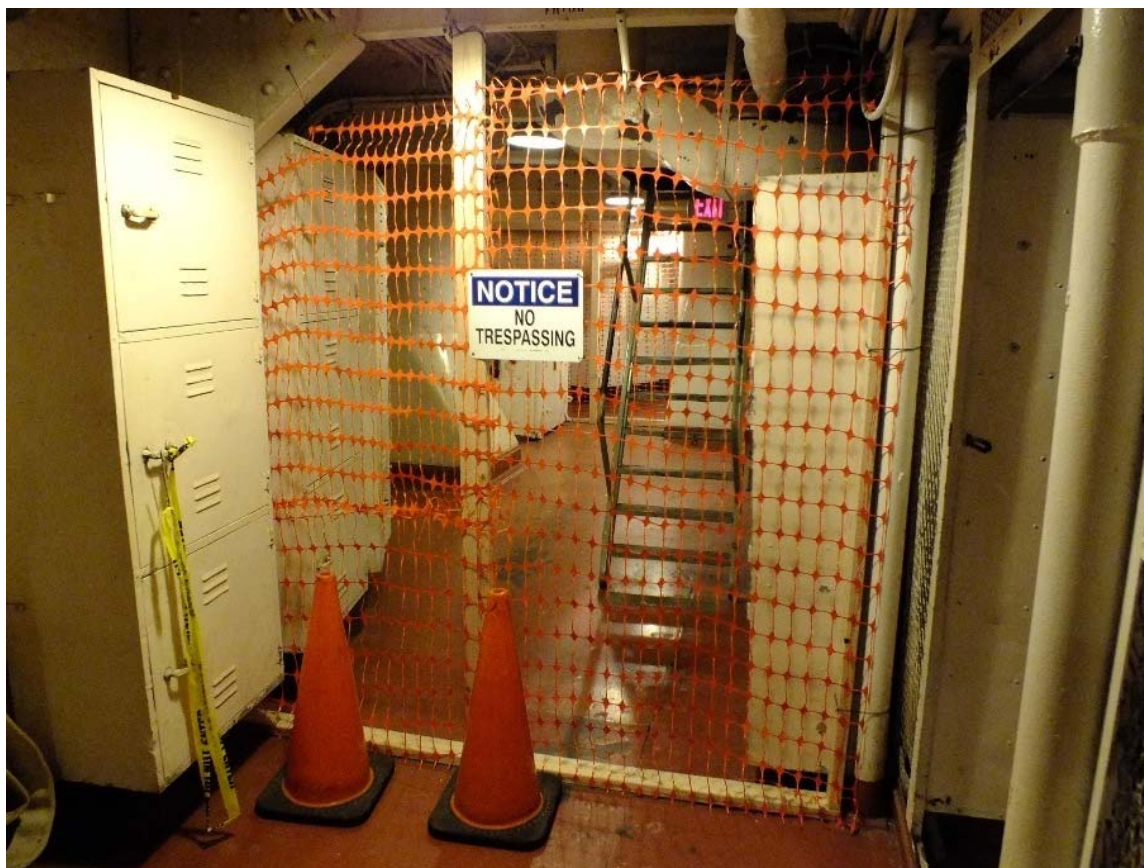
May 2013

Construction zone boundary on 2nd deck. Box cutter staged on construction side to facilitate emergency egress of contractor personnel.

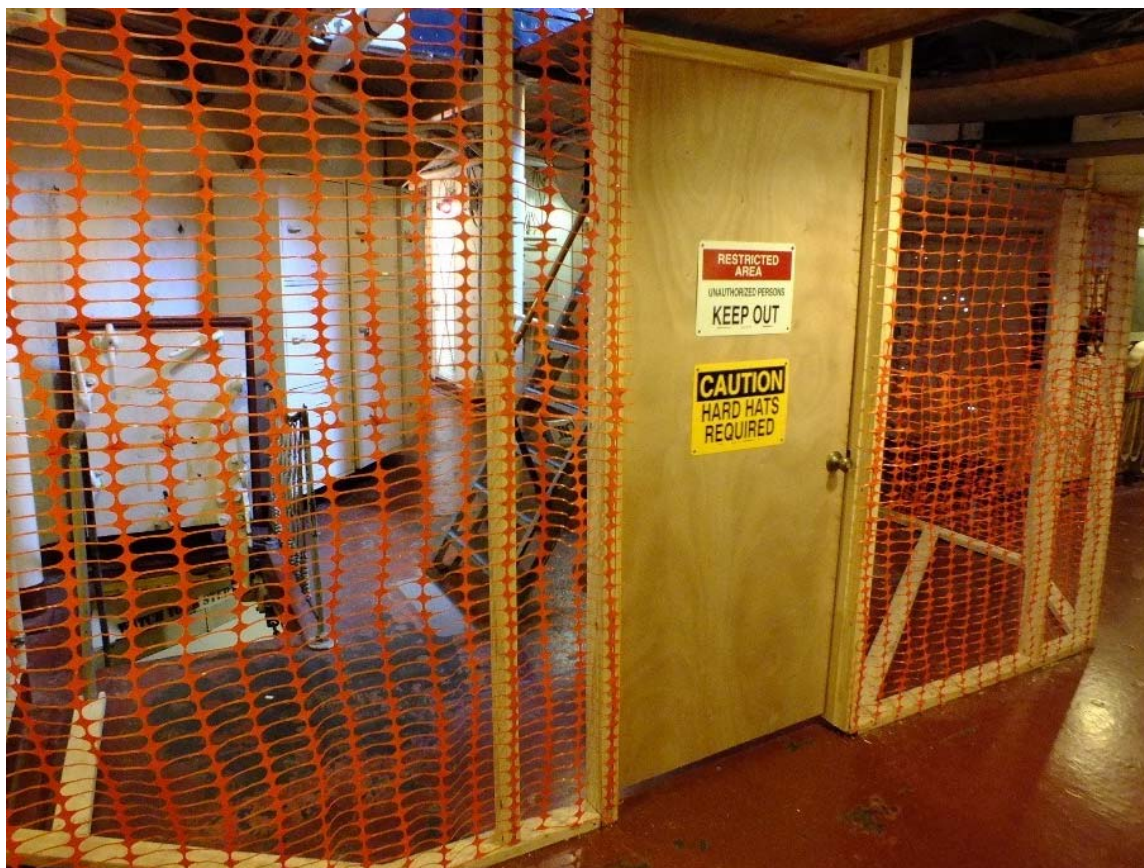
May 2013

Construction zone boundary on 2nd deck. Note keyed man door for access by TPWD Inspectors. Only senior TMC personnel and necessary TPWD staff have keys.

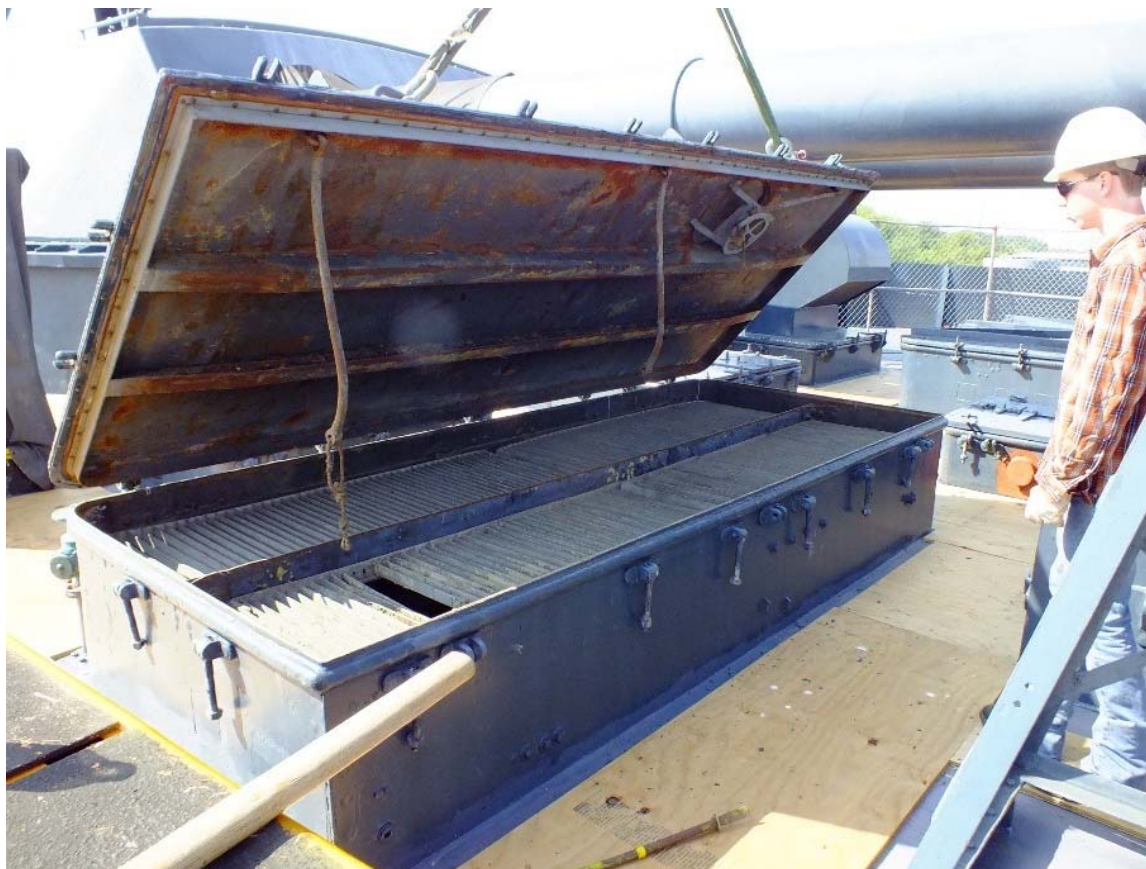
May 2013

Opened vertical access trunk on main deck, exposing first bomb grate.

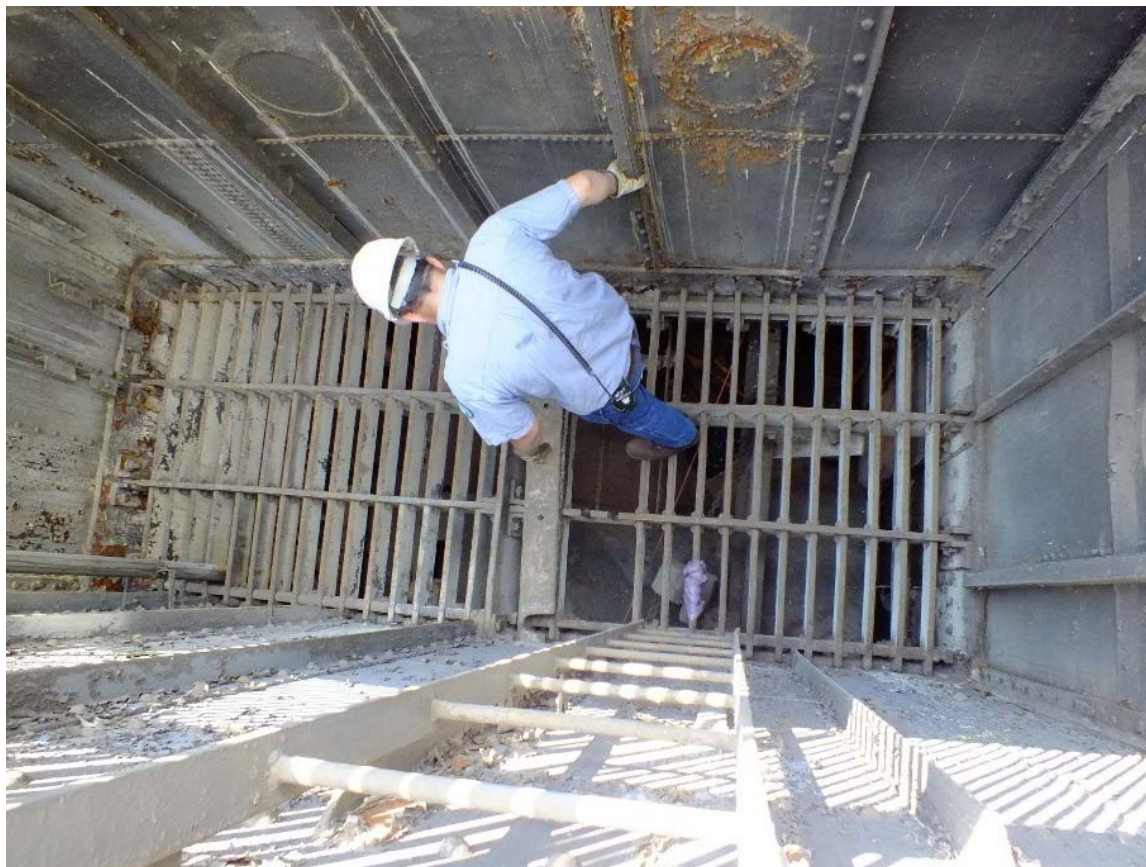
May 2013

Opened vertical access trunk on main deck, exposing lower bomb grate (upper grate removed).

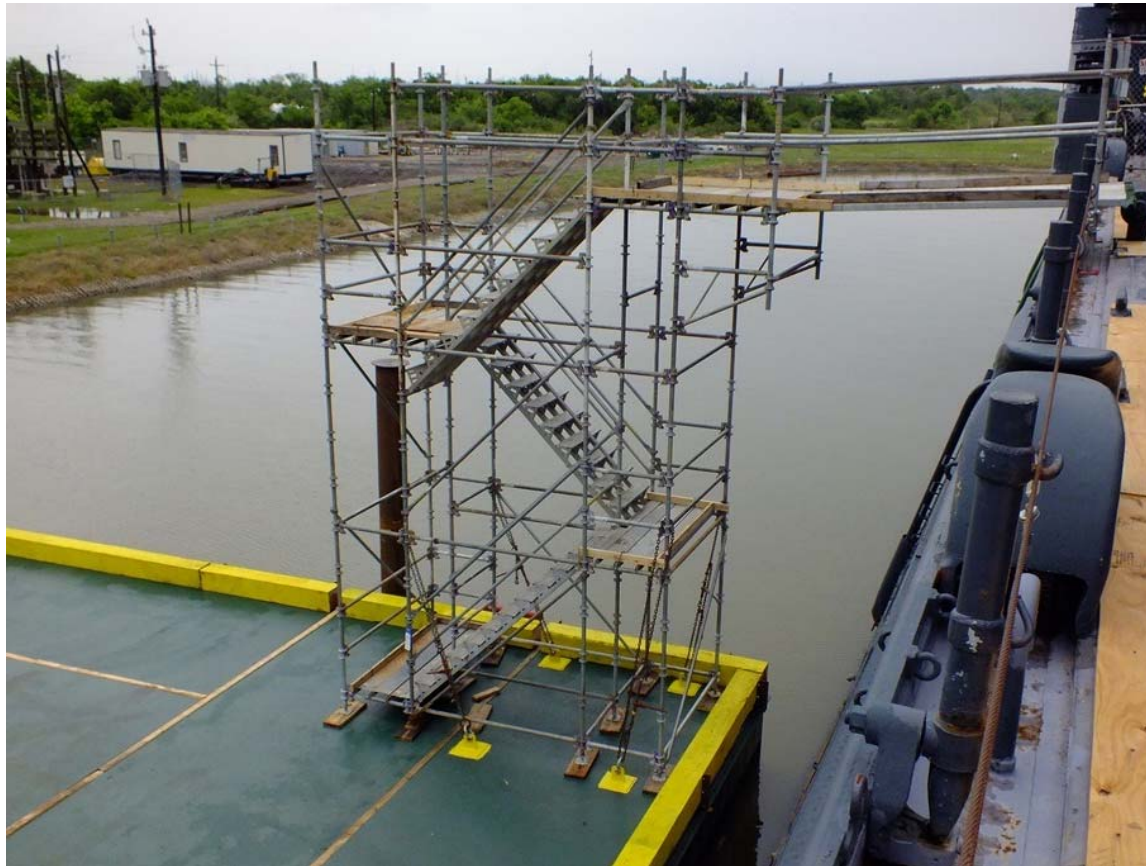
May 2013

Completed personnel access scaffolding from spud barge. Note 12"x12" timber curbing and painted , welded support points for scaffold.

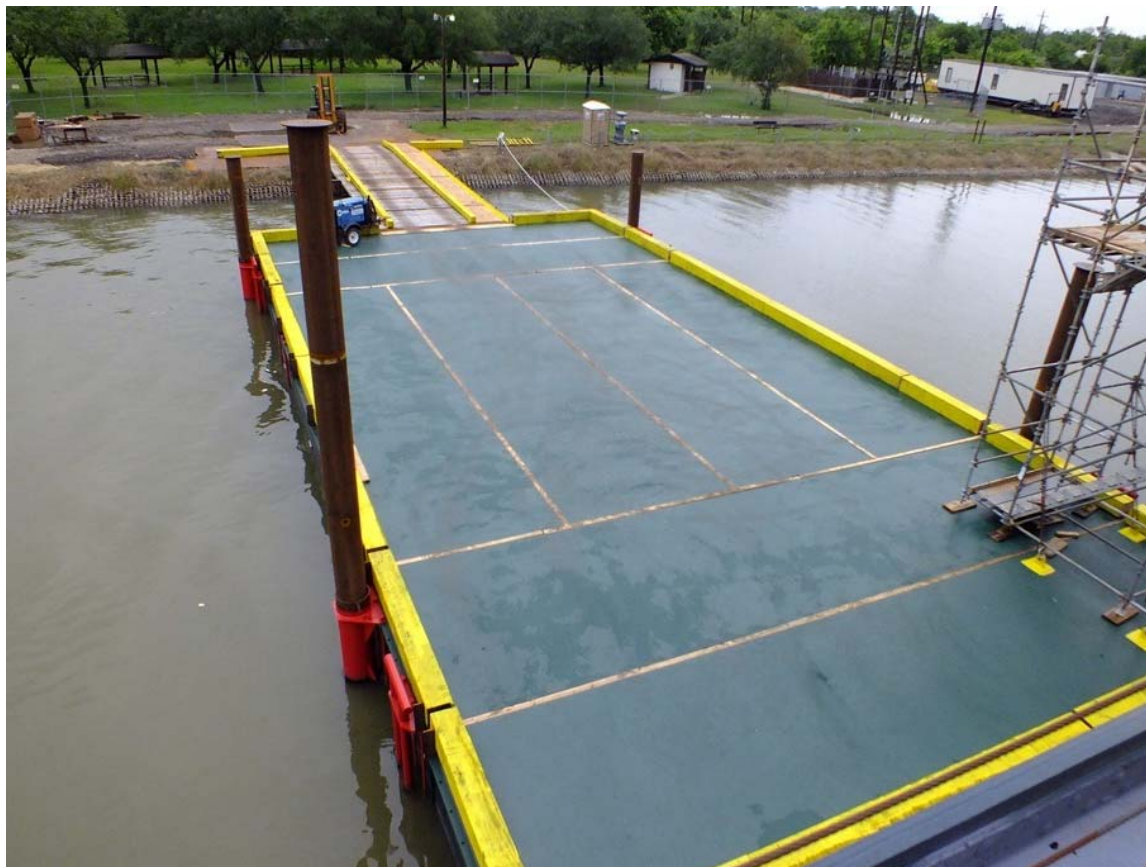
May 2013

Completed spud barge and personnel scaffolding assemblies.

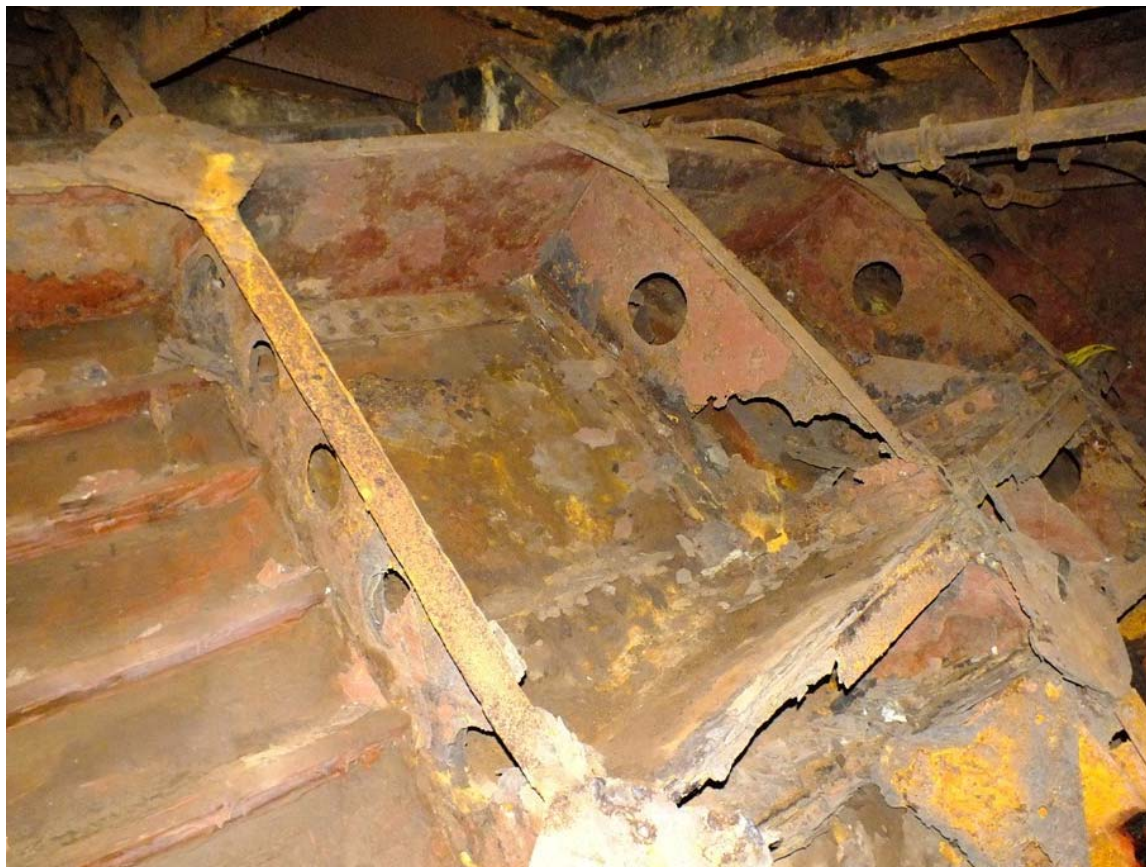
May 2013

Typical condition of frames in Trimming Tank D-12 prior to construction.
Starboard.
